Manhole Inspection Summary

Manhole # S39GG1004MH

Insp Date: **8/28/07 1:33 PM**

Location Address: **3930 LOWNDES AVE**

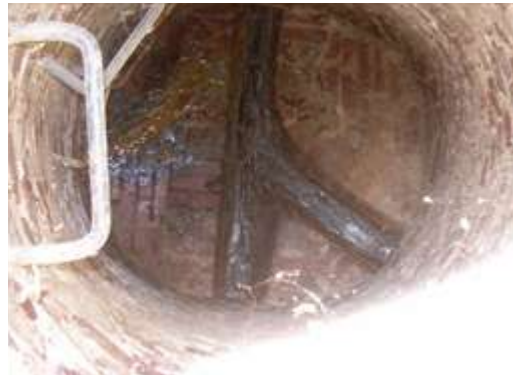
Top View

Corroded steps. Bench debris.

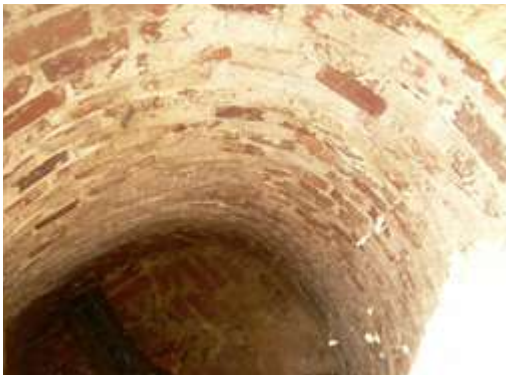
Defect

Corbel and Barrel infiltration.

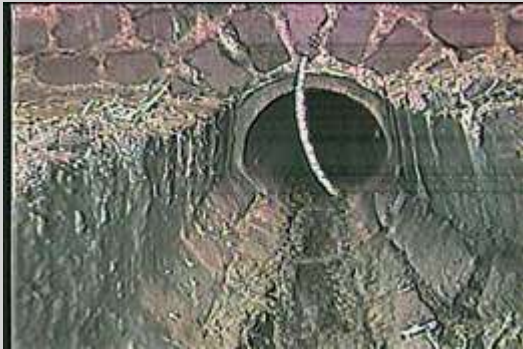
8 in. Circular Gravity Sewer Pipe Out @ 12 O'Clock

Channel deterioration.

Infiltration: **Evidence** Pipe Seal Cond: **Unknown**

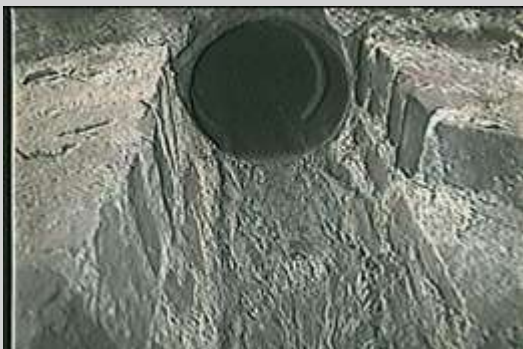
8 in. Circular Gravity Sewer Pipe In @ 4 O'Clock

Infiltration: **Evidence** Pipe Seal Cond: **Unknown**

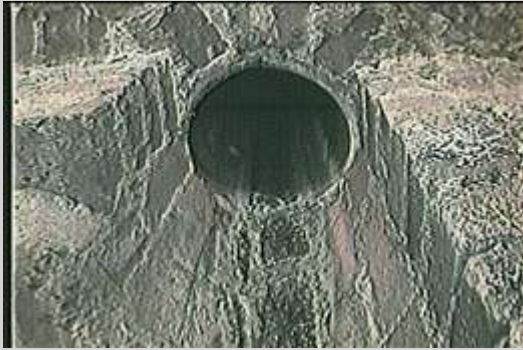
Pipe In @ 6 O'Clock

Infiltration: **Evidence** Pipe Seal Cond: **Cracked**

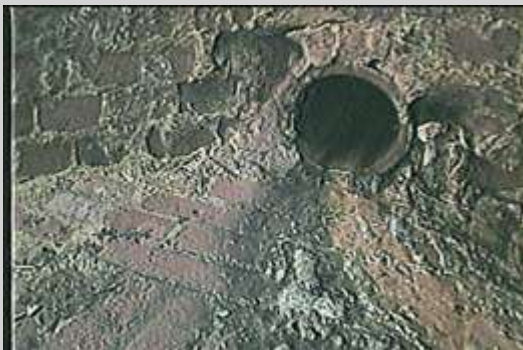
Pipe In @ 9 O'Clock

Infiltration: **Evidence** Pipe Seal Cond: **Broken**
